### Upgrading a Lime Kiln Chain Section to Reduce Dust Loading and Improve Thermal Efficiency

# UPGRADING A LIME KILN CHAIN SECTION TO REDUCE DUST LOADING AND IMPROVE THERMAL EFFICIENCY

Peace River Pulp Division  
Daishowa Marubeni International Ltd.  
Peace River, AB CANADA

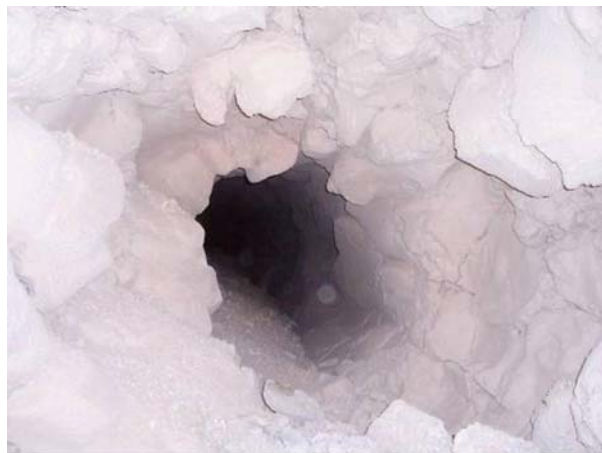
**Figure 1.** Ring formation in the PRPD lime kiln

Recycled dust is an integral part of normal kiln load. Dust purging thus removed a portion of the normal kiln load and resulted in variable kiln load (product bed depth) along the length of the kiln. This made it difficult to judge how much heat was required at any one time to adequately calcine the lime mud feed, and resulted in undesirable kiln thermal cycles. Kiln thermal cycles exacerbated ring buildup downstream of the chain section (Figure 1). Ring formation accelerated local gas velocities and allowed more solids to accumulate behind the ring, as schematically shown in Figure 2. Some of the accumulated solids were then entrained in the high velocity gas stream as dust. Thus a cycle of dust purging - thermal cycle - ring formation - accelerated gas velocities - entrained dust - dust purging - continued to perpetuate itself.

Prior to the chain system upgrade, ring formation downstream of the chain section near the middle of the kiln was a common occurrence (Figures 1 and 13). The build-up was generally difficult to eradicate, and had to be periodically physically removed using the Powershot nozzles. Since the chain system upgrade, the formation of mid-kiln rings seemed to have occurred less frequently. The rings seem to be softer and Powershot operation is not required as often as before the upgrade.

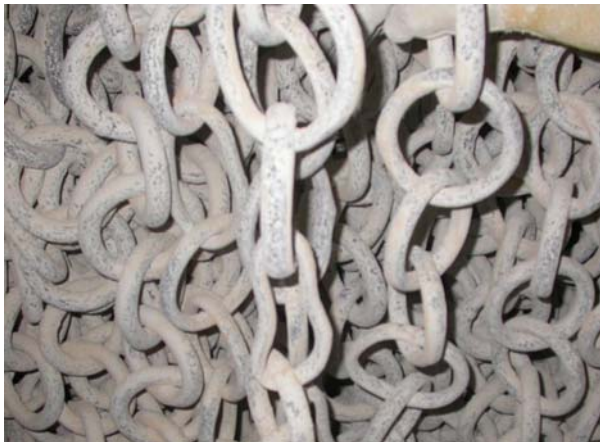
**Figure 3.** *Thinned and warped round-link chain*

Increased lime production necessitated burning additional natural gas. The original round-link chain was unable to withstand the extra heat and began to thin and burn-out more rapidly (Figure 3). Hangars began to fail, and entire

lengths of chain appeared in the product lump crusher. The resulting lack of heat transfer surface area in the chain section increased natural gas consumption and caused feed end gas temperatures in excess of 300°C. High exit gas temperatures, in turn, thermally damaged the baghouse socks of the dust handling systems, exacerbating the dust handling issues.

In June 2004, the kiln cold end internals were completely removed and an entirely new chain system installed. The new chain system consisted of: a shroud over the lime

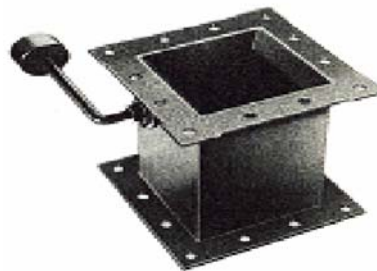
**Figure 4.** *Trickle valve installed on outlet of baghouse*

remainder of the system was achieved. To address the second problem, a trickle valve (Figure 4) was installed on the outlet of the baghouse; this valve effectively prevented tramp air from entering the baghouse and evened out flow of dust into the lime mud feed screw.
